**Mekong Cross-Boundary Impacts: Ecological
Changes and Communities' Livelihoods
A Case Study in Kraom, Kaoh Snaeng, and
Tonsang Villages, Stung Treng Province**

JULY, 2023

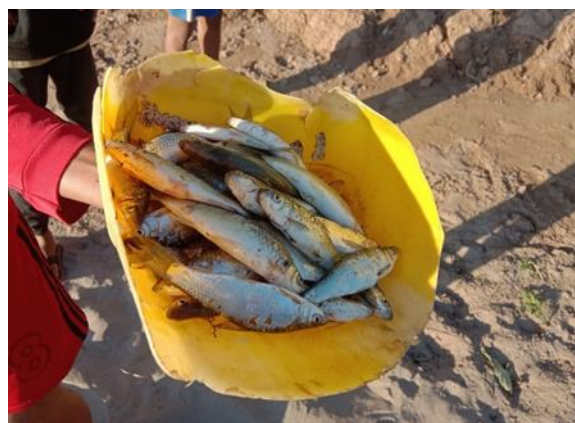
Photo 1: Fish Catch in Kaoh Snaeng Village

Table 2 provides information on fish catch (in kilograms) in Kaoh Snaeng Village for the years 2019 and 2022, categorized by fish gear used. The fish gear mentioned in the table are Gillnets, Hook Longline, Cast nets, and Fish Traps (Lob).

In 2019, fishers using Gillnets were able to catch between 5 to 10 kilograms of fish.

This catch was obtained by fishers who operated 10 sets of gillnets, each measuring 20 meters, for a duration of 13 hours. In 2022, the fish catch using Gillnets decreased slightly to 2 to 5 kilograms.

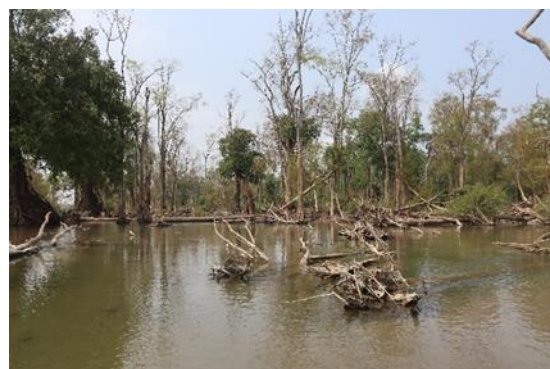
Photo 2: Flooded Forest Situation in Kaoh Snaeng Village

Table 5 presents the data on flooded forests in Kaoh Snaeng Village, including the locations and areas in hectares. The table also compares the changes in flooded forest areas between the years 2019 and 2023. The flooded forests in Kaoh Snaeng villages include Rey, Rom Chek, Rom Deng, Tros, Tonlea, Rom Cheng, Thmear,

Reang, Kroch Toek, Pring Toek,...etc. Some flooded forests have been greatly reduced including Romcheng, Romdeng and Rey.

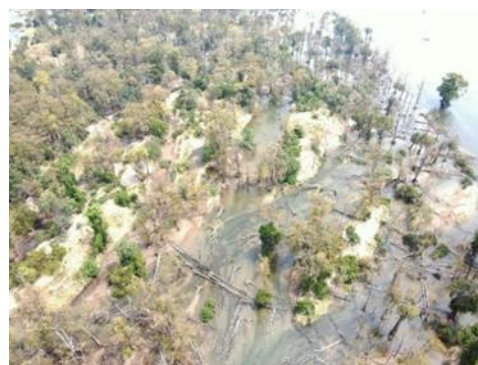
Photo 3: Flooded Forest Situation in Kaoh Han in Kaoh Snaeng Village

In Kaoh Snaeng Village, the trends in flooded forests vary across different locations. Kaoh Samrong had an initial area of 1.5 hectares, with a 10% decrease in flooded forests in flooded forest areas over the four-year period. Kantouy Kaoh Han started with an area of 50 hectares, experiencing a 30% reduction in flooded forests in flooded forest areas. Kbal Kaoh Han had an initial area of 5 hectares, which decreased by 50%. Kan Tuy Kaoh Snaeng started with an area of 1 hectare, with a 40% decrease in flooded forests in flooded forest areas. Kbal Kaoh Snaeng had an initial area of 40 hectares, experiencing a 10% reduction, and Khang Lech Kaoh Snaeng started with an area of 10 hectares, also with a 10% decrease in flooded forests in flooded forest areas.

Similar to Kraom Village, the decline in flooded forests in Kaoh Snaeng Village has significant implications for fish populations and the overall ecosystem. Flooded forests provide crucial habitats for fish, serving as spawning grounds, shelter, and food sources. They also contribute to water quality regulation and the maintenance of ecological balance.

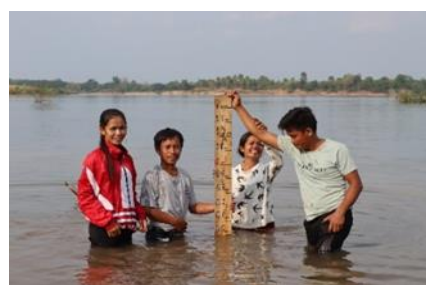
Photo 4: Water Level Pole in Kraom Village

In Kraom Village, there were instances of floods in certain parts of the village and some areas of rice fields during the rainy season. However, there were no floods in the village in either 2022 or 2023. The water level in 2022 was lower during the rainy season compared to 2018, with a difference of 1.70 meters. However, during the dry season, the water level in 2022 was higher than in 2018, with an increase of 1.10 meters. Similarly, in dry season, water running was stronger 2023 than 2019. It was observed that the irregular water fluctuation has occurred since the Don Sahong³ hydropower dam construction and operation.

Similarly, in Kaoh Snaeng Village, the water used to experience seasonal fluctuations, with the water level rising between June and October and dropping from November to May. However, there have been noticeable changes in recent times. The water flow is not as strong as it used to be, and the fluctuations in water levels now occur every three days. In Kaoh Snaeng Village, the water level in 2022 was lower during the rainy season compared to 2018, with a difference of 1.44 meters. During the dry season, the water level in 2022 was higher than in 2018, with an increase of 1.10 meters.

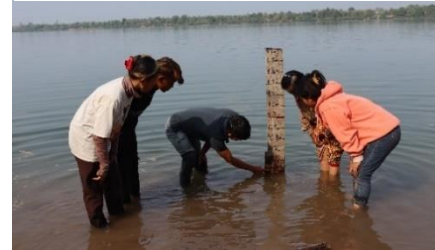
Photo 5: Photo 5: Youth Activity in Water Fluctuation Reading in Tonsang Village

In Tonsang Village, water fluctuation has become irregular compared to the past three years. After the construction and operation of hydropower dams in Lao PDR, there have been noticeable changes in water fluctuations. Since increase in hydropower dams (Dong Sahong hydropower dam and Lower Sesan 2), the water level used to rise during the day and recede at night, with a height of approximately 30 centimeters. The irregular water fluctuations in height of around half meters have sometimes occurred within three days.

The water level in 2022 was lower during both the rainy and dry seasons compared to 2018. The difference in the water level during the rainy season was 1.5 meters, while during the dry season, it was 1 meter.

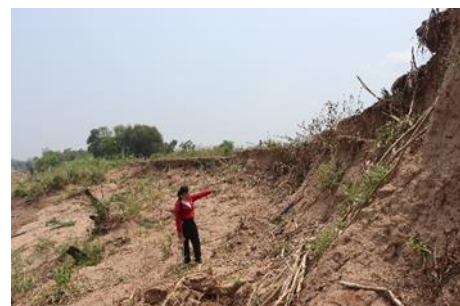
Photo 6: Community Researcher Field Visits at Riverbank Slide in Kaoh Snaeng Village

The research findings on riverbank slides in Kaoh Snaeng Village reveal a concerning trend of multiple occurrences in various locations over the span of three years. Location 1, known as Kantuy Kaoh Samrong, experienced a riverbank slide measuring approximately 100 meters in length and 20 meters in width from 2019 to 2022. Similarly, Location 2, named Khang Lech Kantuy Kaoh Han, witnessed a slide of about 200 meters in length and 30 meters in width during the same period. Location 3, Kantuy Kaoh Snaeng, also had a slide spanning approximately 100 meters in length and 20 meters in width. Lastly, Location 4, Kandal Kaoh Snaeng, encountered a slide measuring about 80 meters in length and 20 meters in width. These findings highlight the vulnerability of the riverbanks in Kaoh Snaeng Village, necessitating further analysis to understand the causes and impacts of these riverbank slides.

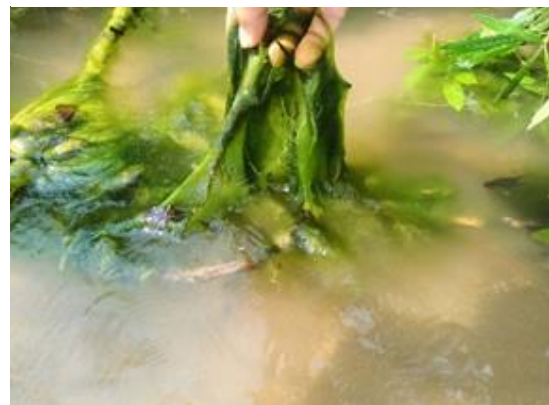
Photo 7: Algae Booming in Tonsang Village

The research findings indicate that the presence of algae in the three target villages has shown varying trends. Tonsang village has experienced an increase in algae since 2019, with a significant increase observed in 2021. Previously, algae was predominantly found on rocks in river, but now it is present all over the river in 2023.

The increase in algae has disrupted the fishing activities of fishers, especially those using gillnet operations. The algae tends to adhere to the gillnets, making it difficult for the fishers

to catch fish. As a result, the fishers have to regularly remove the algae from their gillnets. In the past, the fishers have removed algae from their gillnets once a day. However, due to the significant increase in algae, the fishers now have to remove algae from their gillnets four times a day as of 2023. This increased frequency of algae removal highlights the impact of the algae growth on the efficiency and productivity of the fishing operations in the area. On the other hand, in Kaoh Snaeng village, there has been a slight decrease in the presence of algae in the river since 2015, with a significant decline observed between 2019 and 2020. Previously, the river was heavily covered in algae, which made it challenging for fishers to catch fish. However, in recent years, there has been a noticeable reduction in the amount of algae present in the river. This decrease in algae has had a positive impact on the fishing conditions, making it easier for fishers to pursue their activities and improve their catch. Fishers had also concerned that the decline in algae have negatively impacts on fish stocks as the algae is important habitat for fish and also feed for some fish species.

Conduct Research on Factors Influencing Algae Growth: Request partner organizations and government experts to conduct scientific studies to better understand the factors contributing to the increase in algae growth. This research can help identify the root causes and inform targeted interventions to mitigate the growth of algae.

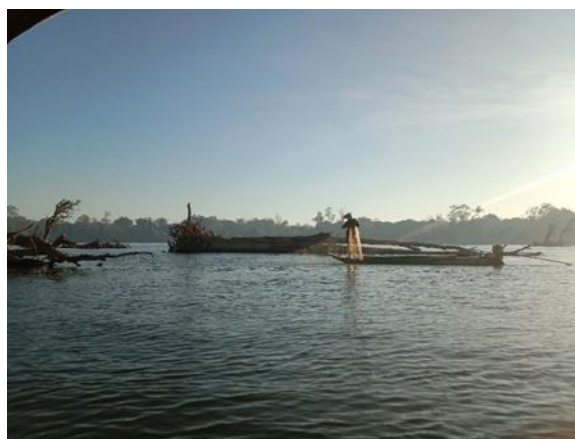
Photo 8: Fishing Activity in Kaoh Snaeng Village

In Kaoh Snaeng Village, the income from fish catch ranged from 30,000 to 50,000 Riel per day in 2019. This income remained relatively stable, with slight fluctuations, throughout the years. By 2022, the income decreased slightly to 10,000 to 30,000 Riel per day. Similarly, the expenses for food remained consistent, ranging from 10,000 to 15,000 Riel per day across the years. These figures

suggest that while the income from fish sales did not show significant changes, the costs of food remained relatively constant for the villagers.
